# Water Quality

## WOTS Reservoir Erosion Control and Revegetation Workshop and Demonstration

Smithville Lake, Smithville, Missouri

by Hollis H. Allen, Michael A. Watkins, and Bruce K. Clark

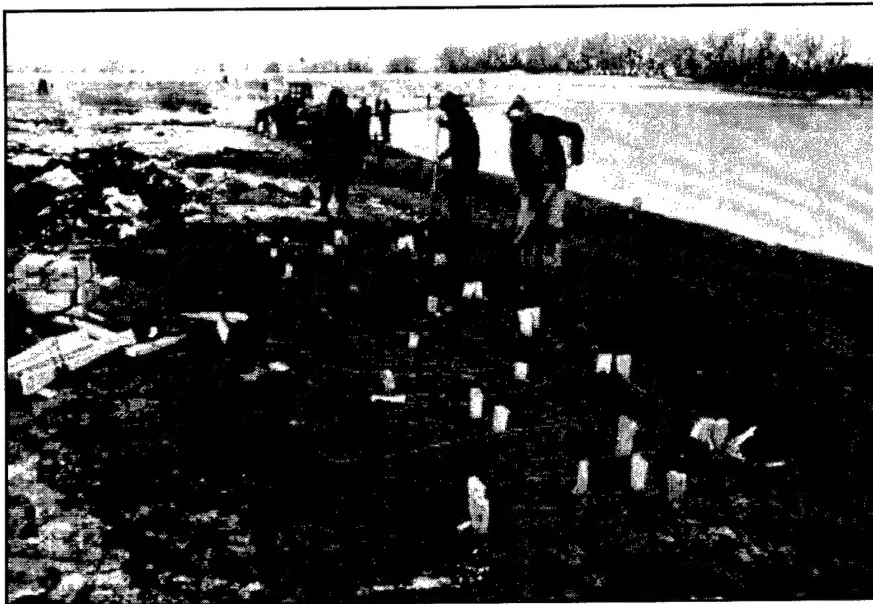
**Figure 2. Breakwater made from a coir geotextile roll with workshop participants installing a brush mattress made from willow**

The second breakwater treatment consisted of a coir geotextile breakwater that covered 130 ft of shoreline. The breakwater, like the one above, was designed to be temporary. It will diminish wave energy and will allow plants to be planted both behind and in it. The breakwater was constructed of nonwoven coir fiber made from coconut husks and bound by either a choice of woven coir rope or polyethylene rope. The demonstration breakwater was 20 in. in diameter and was bound by polyethylene rope for durability in a wave environment. The shoreward side of the breakwater was planted with emergent aquatic vegetation immediately adjacent to the breakwater, with live willow whips laid down and secured as a brush mattress, in accordance with methods described in Allen and Leech (1997). The coir breakwater with an incom-

plete brush mattress is shown during installation in Figure 2.

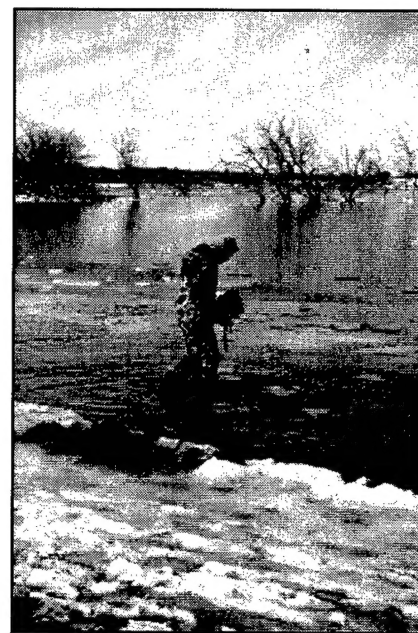
Figure 5. Submersed aquatic vegetation, such as coontail, being deposited in shallow water

The last treatment installed also covered a 130-ft reach of shoreline and was the treatment most protected from wave action. The configuration of the shoreline and its existence farther up and to the east along the peninsula provided more protection from the wind and boat activity. Here, WES believed that both emergent aquatic plants and submersed aquatic vegetation could work without either the protection of breakwaters or any extra anchoring device, such as a geotextile mat or plant roll. This treatment also met one of the MDC objectives of restoring both emergent and submersed aquatic vegetation for the benefit of a wider variety of organisms that are dependent on such plants. As in the previous treatment, dormant willow poles and cuttings were planted shoreward of these plants. Emergent aquatic vegetation was planted by transplanting sprigs directly into the lake bed, whereas clumps of submersed aquatic

vegetation, such as coontail (*Ceratophyllum demersum*) were simply deposited in about 1 to 2 ft of water (Figure 5).

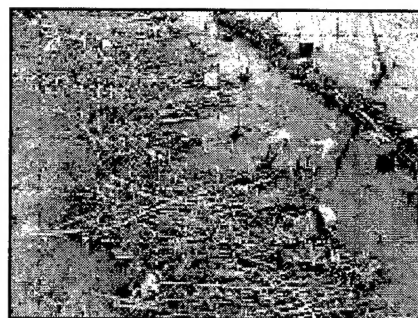
Figure 6. Brush mattress behind coir geotextile roll showing sprouts of willow and arrowhead

The demonstration treatments were revisited in August 1998 by Corps personnel. Both areas behind each breakwater type, the branchbox and the coir geotextile roll, were capturing sediment and essentially reclaiming eroded shoreline. Particularly, new vegetative sprouts were occurring in the brush mattress behind the roll. These included both young willow and other emergent aquatic plants such as broad-leaved arrowhead (*Sagittaria latifolia*) (Figure 6). Other emergent aquatic plants were observed shoreward of the roll (Figure 7). The coir roll breakwater was intended to be planted by inserting sprigs of emergent aquatic plants in it. This action was postponed until lake levels were high enough to wet the roll so plants would not dry out. This planting may take place in the spring of 1999.

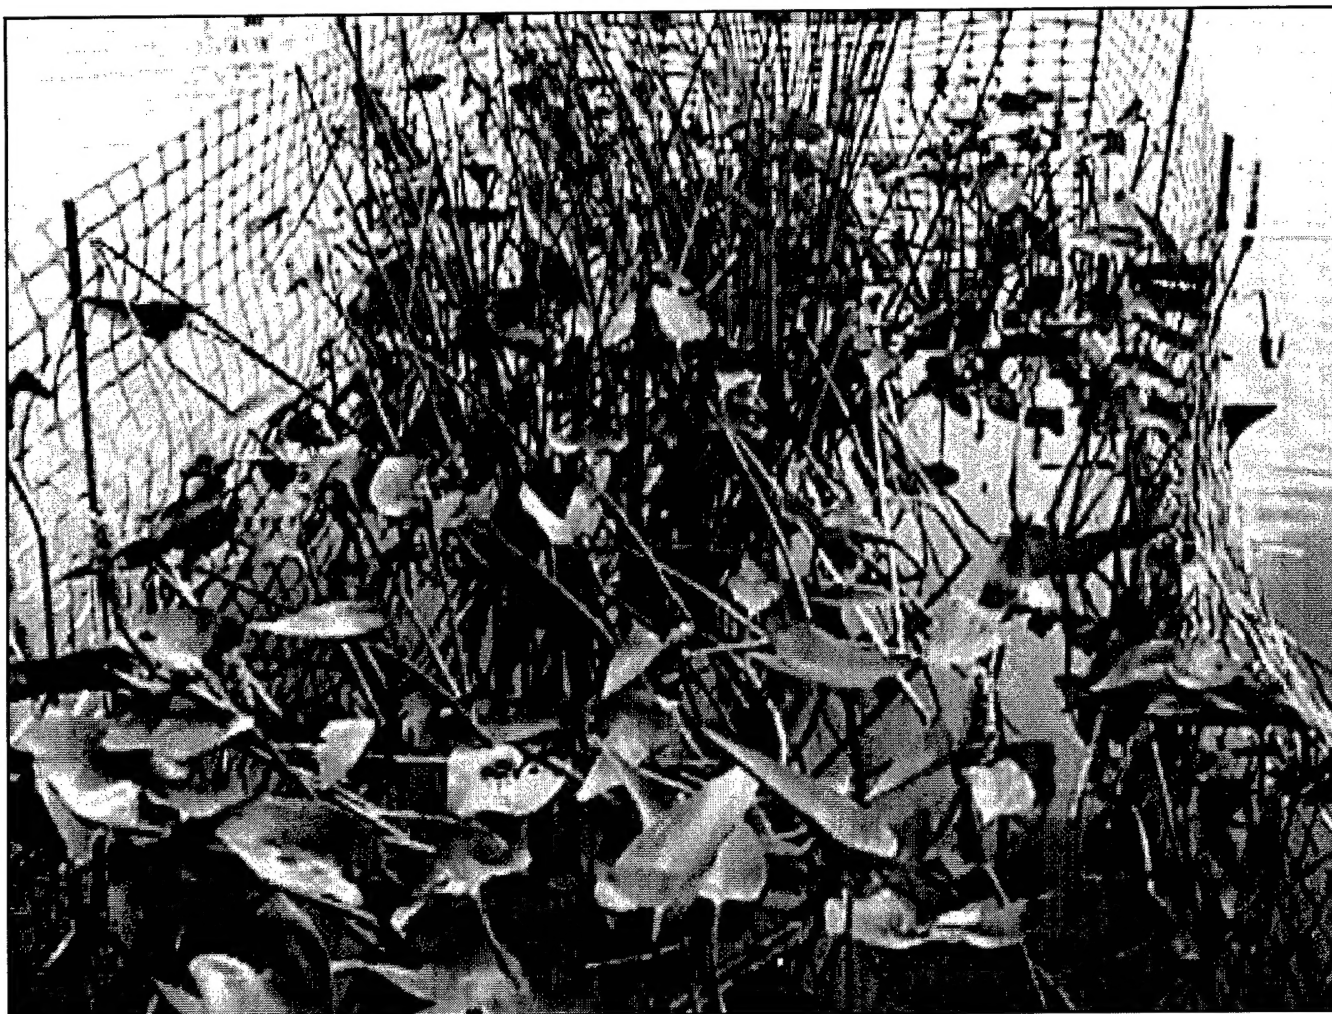
Figure 8. Emergent aquatic plants such as pickerel weed and three-square within an enclosure

Treated areas without breakwaters were most noticeable by the occurrence of emergent aquatic plants in the exclosures, most notably pickerel weed (*Pontederia cordata*), three-square (*Scirpus americanus*), and other bulrush species (*Scirpus* spp.) (Figure 8). Where exclosures were not present, aquatic plants were scarce. The exclosures probably prevented the plants from being extirpated by both geese and carp. Carp are abundant in the reservoir, particularly shallow areas, and the reservoir is noted for its large population of geese, which graze on aquatic vegetation.
